Navajo Abandoned Uranium Mine

Site Screen Report

Mine Name: Casey No. 3
Mine ID: 373

August 2011

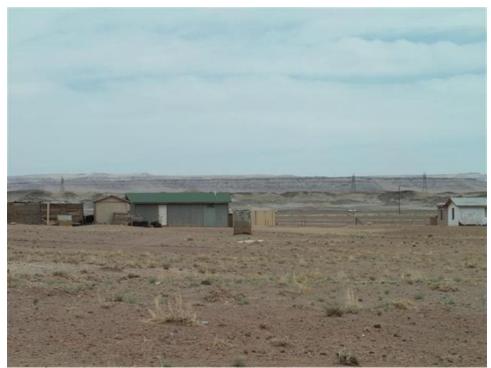
200 feet to 0.25 mile: House compound 0.25 mi SE of site

Photo 3: Mine Site #373; Nearby houses
